FIELD INSPECTION REPORT

Project Name:	Mountain Valley Pipeline	Inspector:	Matthew Grant
Inspection Date:	Wednesday, March 10, 2021	Project Contact:	Brian Clauto
Spread I: Pittsylvania	ST15481+47-ST15447+13	Weather:	Dry

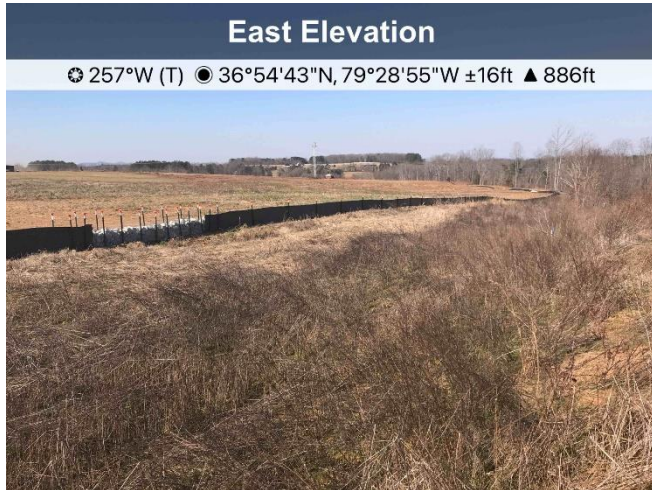
- Comments: Inspected the following resources: S-CC16
- ECD's were in place and functioning at the designated crossing.
- Adjacent active construction site has installed silt fence rock outlet breaks that discharge onto the ROW/ clean water diversions.

- Figure 1: Near St15465+00 SF rock outlet of adjacent property above CWD St15460+00.

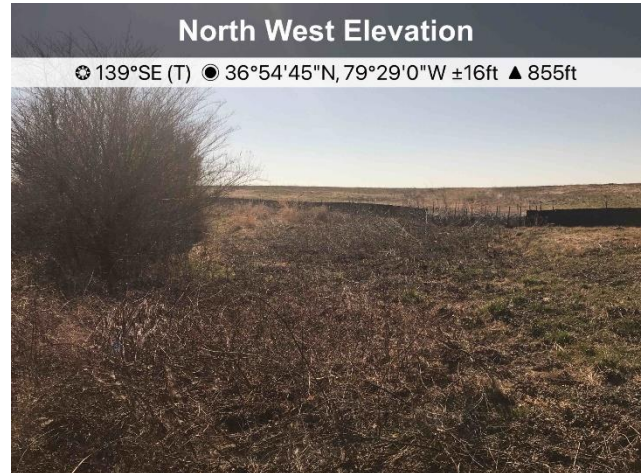
- Figure 2: Near St15460+00 SF rock outlet of adjacent property above CWD St15460+00.

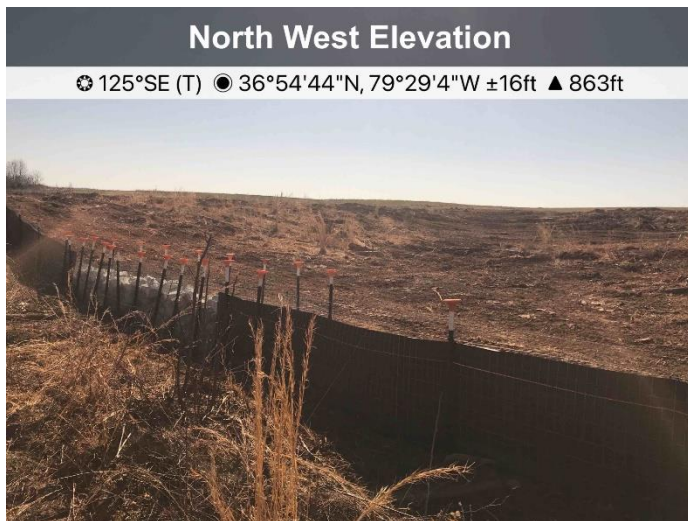
- Figure 3: Near St15459+00 SF rock outlet of adjacent property above CWD St15457+00

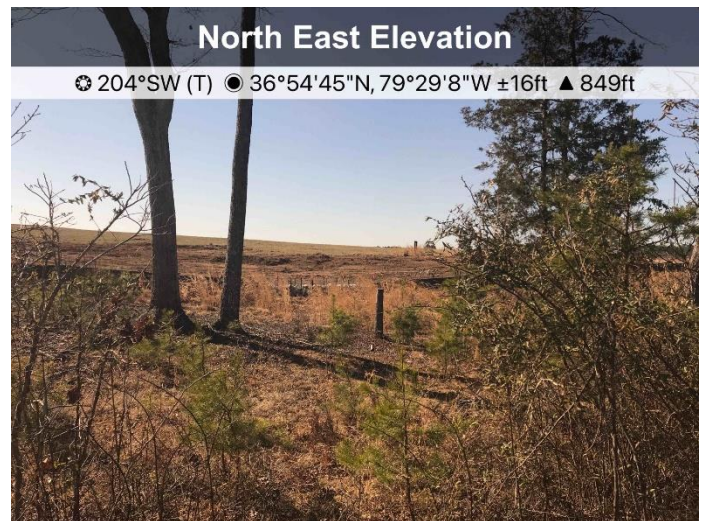
- Figure 4: Near St15454+00+00 SF rock outlet of adjacent property above CWD St15453+00

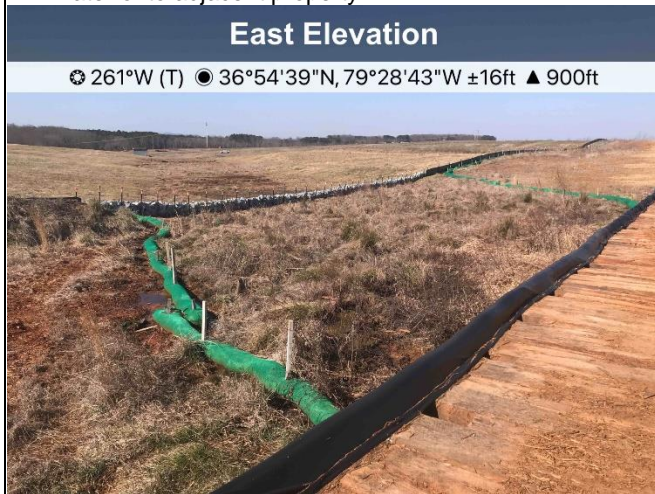
- Figure 5: St15494+77 SF rock outlet installed, ROW discharges water onto adjacent property.

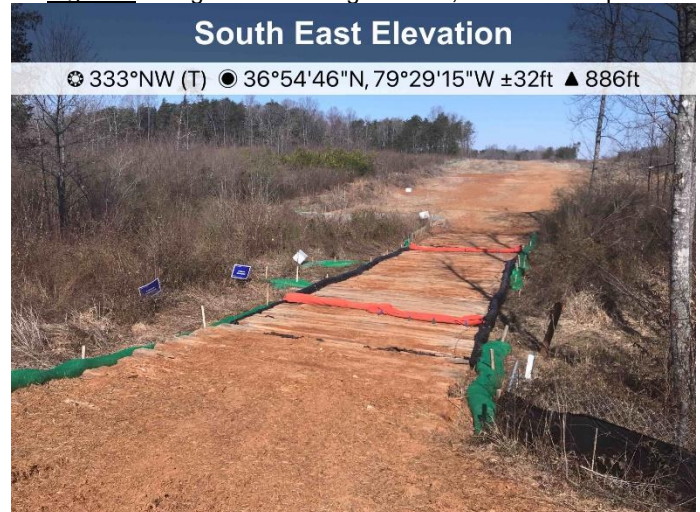
- Figure 8: Designated crossing S-CC16, ECD's are in place.
